**Village of Fox Point, WI  
Beach Drive Shoreline Restoration****MSA FIELD INSPECTOR:**

June 19, 2023

**SUMMARY OF CURRENT JOB PROGRESS**

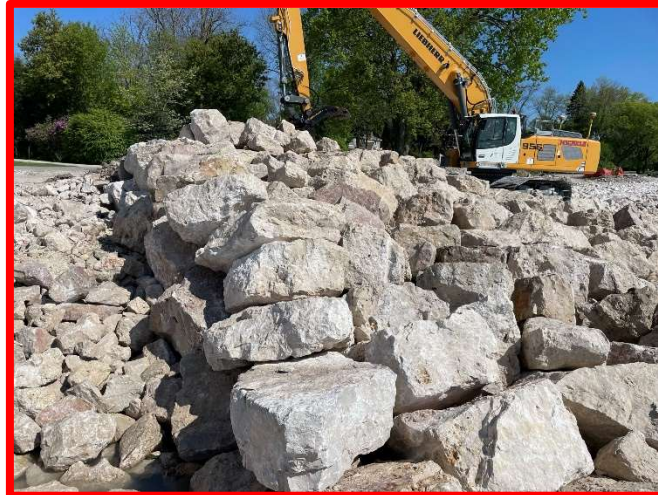
Figure 1: Excavator equipped with GPS technology used to place the revetment stone at the exact right location and elevation. Pictured above creating a trench for storm sewer to be installed.

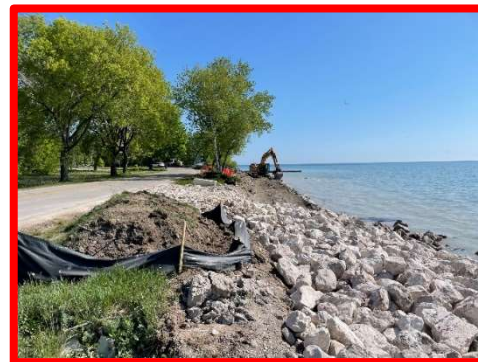
Figure 3: Second excavator equipped with GPS technology clearing debris and preparing the base layer for installation of the armor stone.
